<b>Project Name:</b> Gold King Mine – September 11, 2014	<b>Site Location:</b> Silverton, San Juan County, Colorado	<b>Project No.</b> NA
---	---	--------------------------

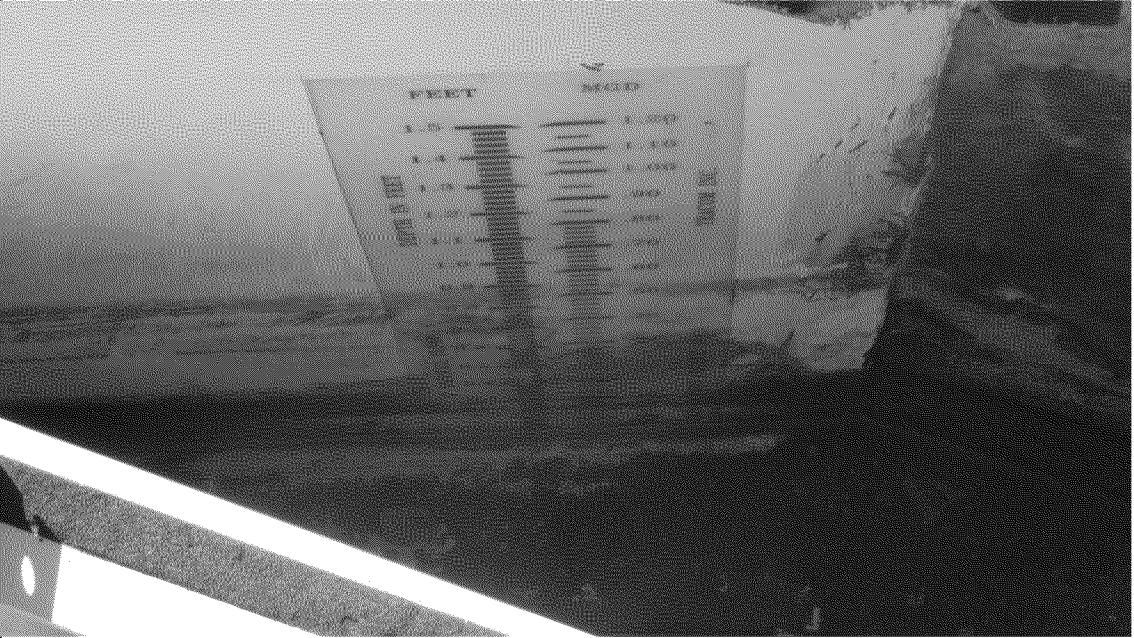
<b>Photo No.</b> <b>3</b>	<b>Date:</b> 09/11/2014	
<b>Direction Photo Taken:</b>  South

<b>Description:</b>  Gold King Mine 3-inch Parshall flume. Note low flow in channel. Photo taken on 9/11/2014 at 12:42 prior to the start of work. Water is at 0.1 feet, which corresponds to 12.55 gallons per minute flow.		
<b>Photo No.</b> <b>4</b>	<b>Date:</b> 09/11/2014	
<b>Direction Photo Taken:</b>  South

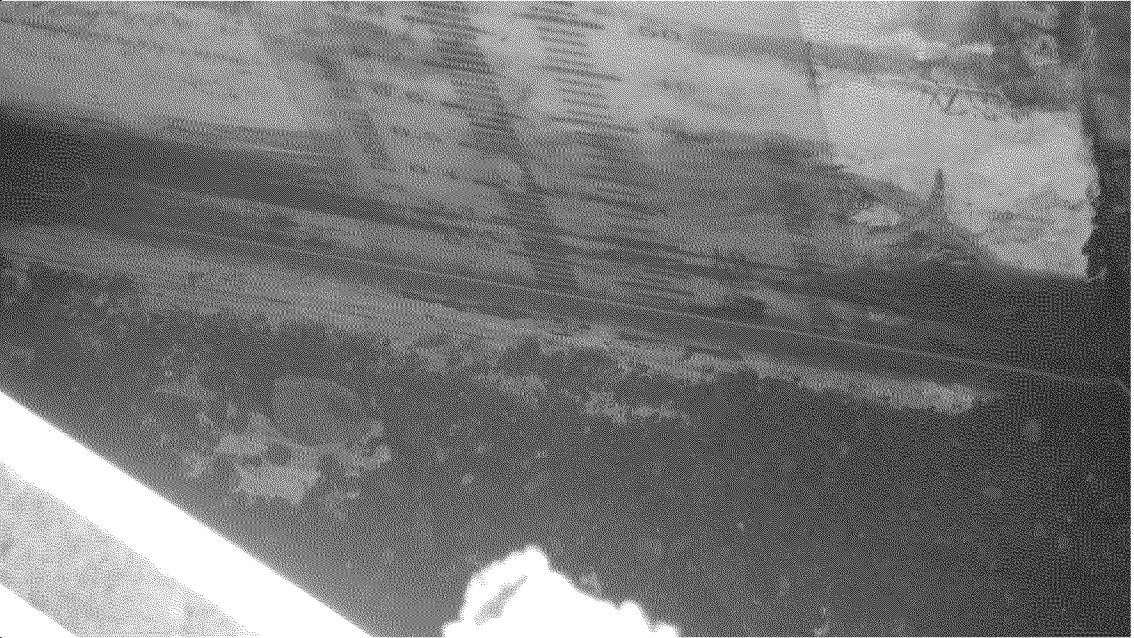
<b>Description:</b>  Gold King Mine 3-inch Parshall flume. Note low flow in channel. Photo taken on 9/11/2014 at 12:43 prior to the start of work. Water is at 0.1 feet, which corresponds to 12.55 gallons per minute flow.
